U.S. CHEMICAL SAFETY AND HAZARD INVESTIGATION BOARD

INVESTIGATION REPORT

VAPOR CLOUD DEFLAGRATION AND FIRE

BLSR OPERATING, LTD.

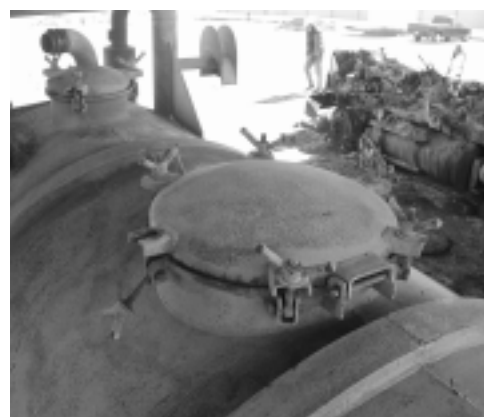
Figure 8. North side truck manway bolts partially removed.

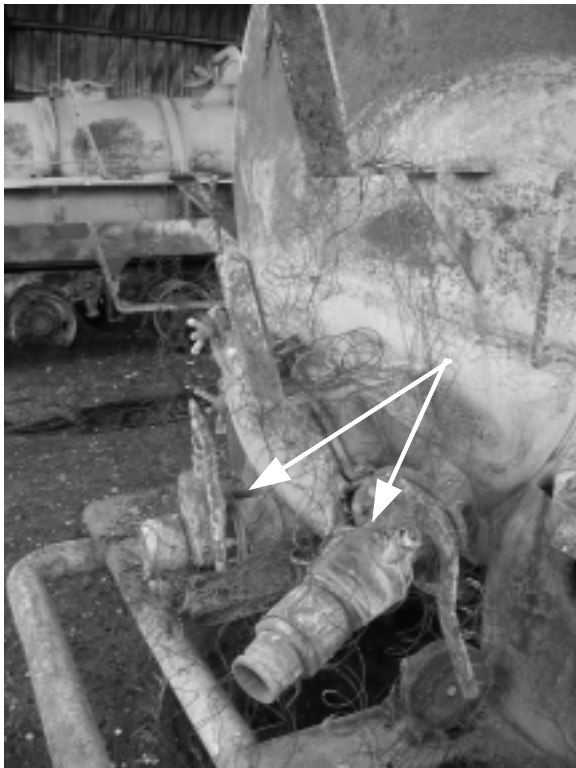
The weight of the valve handle and internal components caused each of the drain valves to return to the closed position during the fire (Figure 9). However, even in the closed position, the fire-damaged valves allowed liquid to drain from the tanks. The sight glass was burned away, and the tanks were empty. All vacuum hoses were destroyed; only the coiled metal wire and connector fittings remained. Physical evidence also showed that the diesel fuel in the tanks did not spill to the pad area or contribute to the pool fire behind the trucks.

Figure 9. Truck tank drain valves in closed position.

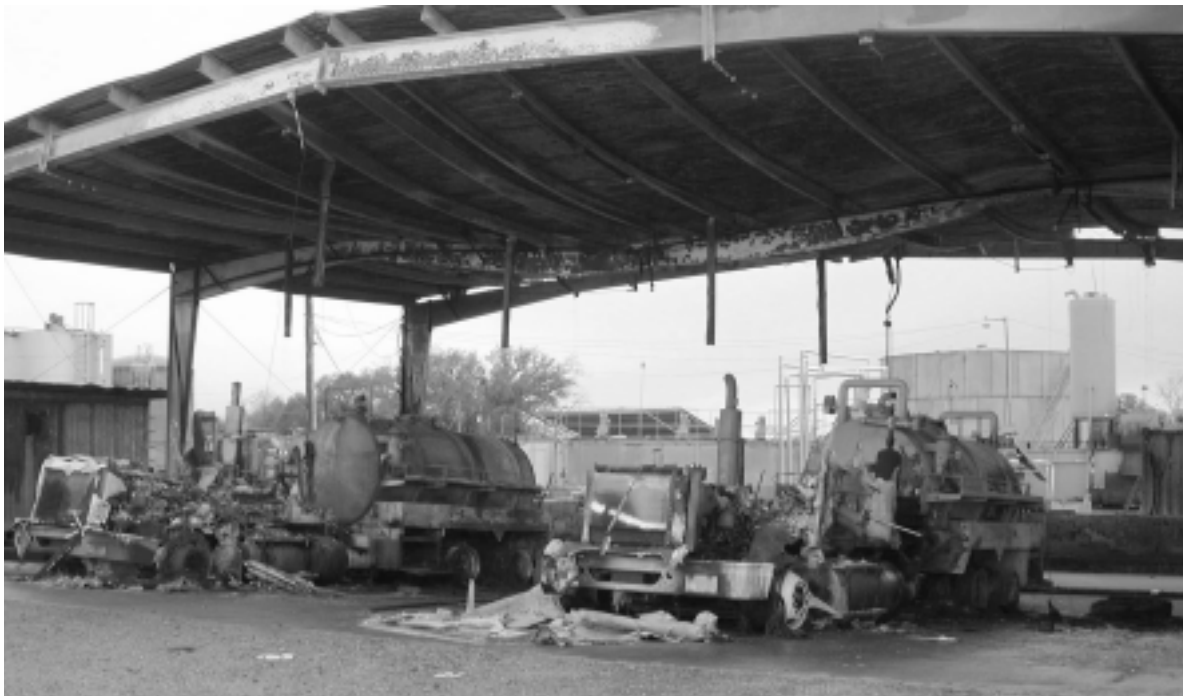
The canopy above the unloading pad sustained major heat damage (Figure 10). The electrical service line attached to the southwest canopy support column was severed, and all ceiling-mounted lighting and the vent fan were destroyed. The emergency eyewash station and shower next to the drivers' shed, the equipment switch panel on the northwest corner wall adjacent to the concrete pad, and equipment in the electrical shed sustained significant radiant heat damage. Fire and smoke damaged the storage room attached to the drivers' shed.

Figure 10. Mud disposal and washout pad, showing burned trucks and damaged canopy.

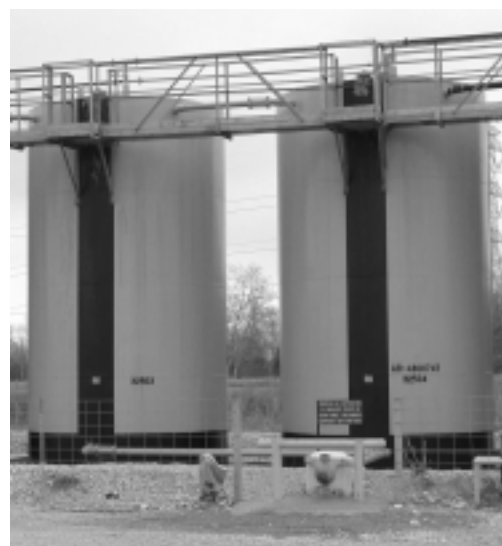
. . . The majority of those questioned during the investigation do not believe that BS&W exhibits a flammability hazard, even though it can originate from highly flammable condensate.

Figure 11. Unlabeled flammable condensate storage tanks, CJ Waller lease.

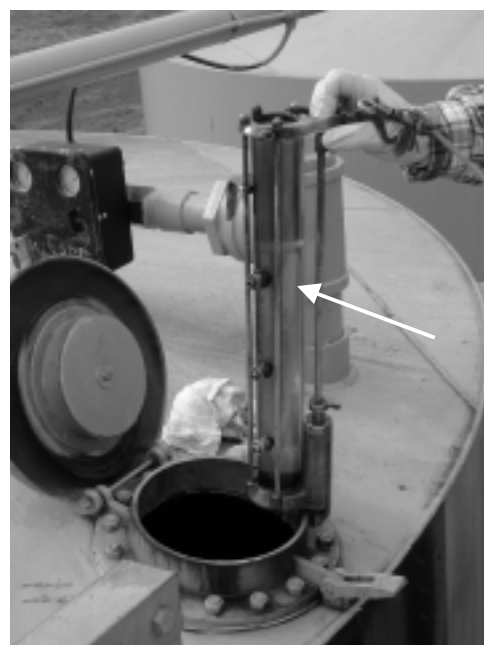
CSB analysis of nine tank BS&W samples from six production wells, including one of the wells involved in the BLSR incident, resulted in flashpoints below 30°F in eight of the samples. (For comparison, the flashpoint of condensate is about -36°F, and the flashpoint of gasoline is about -45°F.) Only one of the storage tank BS&W samples had a flashpoint above 141°F.²⁴ A tank bottom “thief” (Figure 13) was used to ensure that only BS&W was withdrawn from the tanks.

Figure 13. Gauge hatch and tank “thief” showing 13 inches of BS&W below condensate.

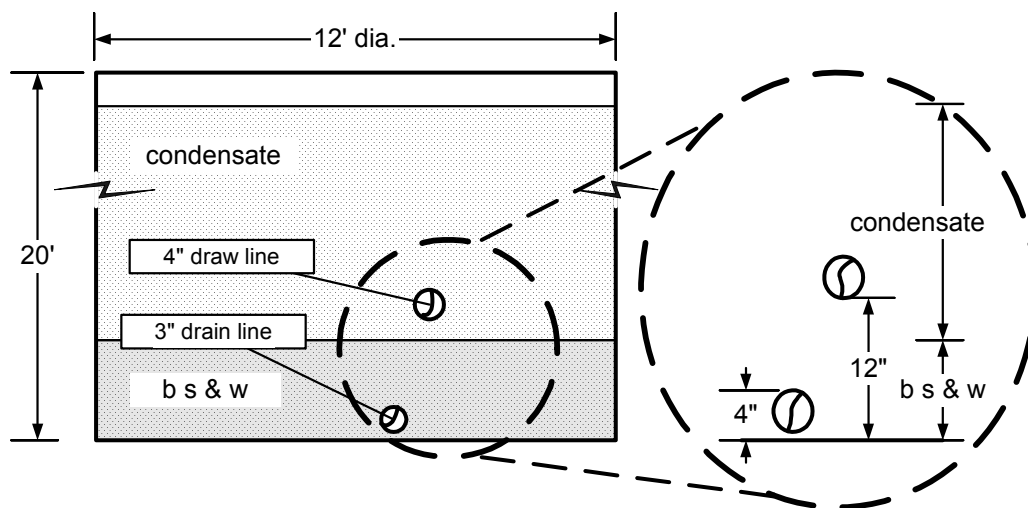
Figure 14. Vertical spacing of storage tank nozzles (180° apart around circumference of tank).

(presumably BS&W) through the drain nozzle, as much as 2 inches of condensate (140 gallons) is mixed with BS&W. The liquid “waste” in the truck tank is actually 25 percent highly flammable condensate.

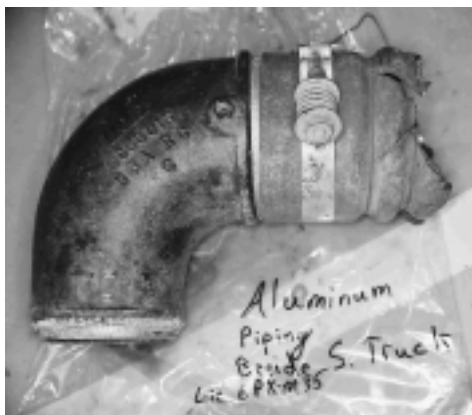
Figure 15. South truck diesel engine turbocharger discharge elbow.

One witness also reported that the hood on the south truck lurched up just before the vapor ignited, suggesting a high-pressure impulse around the engine. The elbow and attached short piece of flexible hose (dark arrow in Figure 16) were recovered and showed no fire damage, providing further evidence that the fitting had come off and fallen to the ground before the fire ignited and destroyed the engine.³²

³²For comparison, evidence suggests that either the north truck engine did not backfire, or the pressure wave from a backfire was not sufficient to blow the fitting off the turbocharger. A portion of the elbow was still attached to the turbocharger housing, and the remainder of the elbow and flexible hose was destroyed.

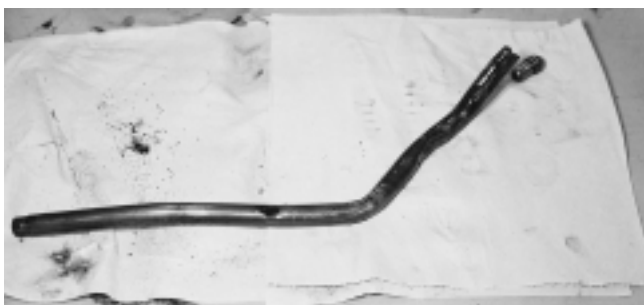
In April 2003, a diesel engine maintenance shop disassembled the two truck engines to determine if either had incurred internal damage caused by over-revving, which would support the backfire scenario. The north truck engine sustained no damage indicative of overspeed. However, the south truck engine clearly showed evidence of overspeed damage, including a severely bent exhaust valve pushtube (Figure 17) and bent exhaust valve. CSB determined that backfiring from the south engine is the most likely source of ignition of the flammable vapor cloud.

Figure 17. Bent exhaust valve pushtube, south truck diesel engine combustion chamber #2.

. . . The south truck engine clearly showed evidence of overspeed damage, including a severely bent exhaust valve pushtube and bent exhaust valve.

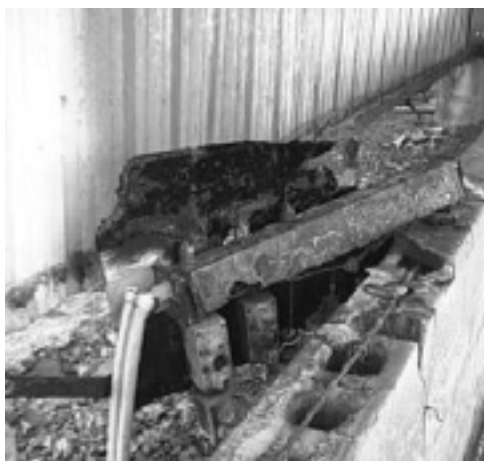
None of these circuits were designed for operation in a flammable vapor environment.

Figure 19. Remains of motor control switch panel.

Physical evidence and eyewitness testimony led CSB to conclude that the vapor cloud was not ignited by a facility electrical circuit.
